ROSS TL-12 STEERING GEAR PITMAN ARM TO SECTOR SHAFT INSTALLATION  
AND  
DEVELOPMENT OF ASSEMBLY SPECIFICATIONS

VEHICLE: 1960 WILLYS UTILITY WAGON

SN: 54168 50039

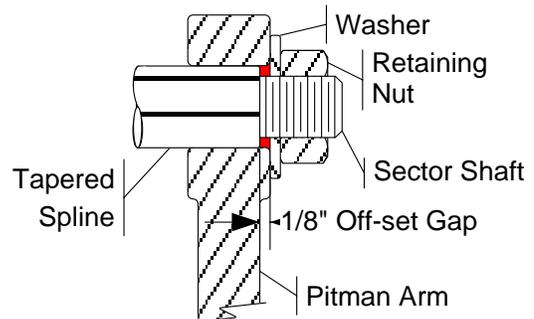
While installing the Pitman arm on the sector shaft, it became apparent that the NOS parts fit differently than the original parts. The Pitman arm did not slide onto the tapered spline as far as the original parts. Fig. 2 shows the original part spline engagement with 1/8" gap between the Pitman arm face and the edge of the sector shaft spline. Fig. 3 shows the NOS part spline engagement and 1/4" gap between the Pitman arm face and the splined section of the sector shaft. An obstruction prevented the NOS Pitman arm from advancing onto the splined section an additional 1/8" to achieve the same spline engagement as the original parts. The 1/8" less spline engagement between the sector shaft and Pitman arm results in about 14% less load-carrying capacity.

Fig. 2. Original Part Assembly with 1/8" Off-set Gap Between Pitman Arm Face and Edge of Sector Shaft Spline

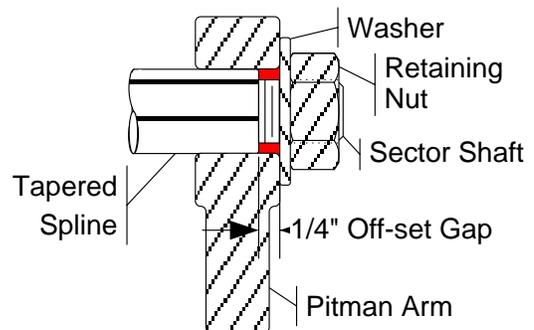
Fig. 1. NOS Part Assembly with 1/4" Off-set Gap between Pitman Arm Face and Edge of Sector Shaft Spline

Original Pitman Arm to NOS Sector Shaft Fit-up – This configuration resulted in the contact pattern shown in Fig. 6 with the 1/4" gap shown in Fig. 3, leading to the conclusion that the NOS sector shaft was dimensionally different from the original sector shaft. The visual inspection (Fig. 4) that revealed incomplete machining of the external blind splines supports that conclusion. The contact pattern was noticeably visible on two sides, 180 degrees apart, indicating that the shaft spline area was somewhat oval-shaped. However, dimensional inspection did not reveal this condition.

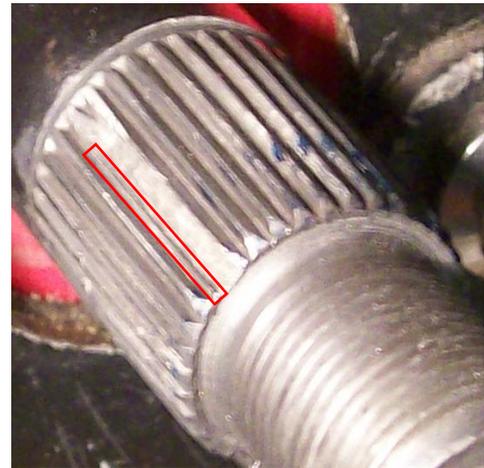
**Sector Shaft** – Fig. 4 shows incomplete removal of one of four blind splines. Incomplete machining caused interference with the Pitman arm hub. The other three blind splines had the same defect. The remaining 32 splines are in good condition.

Fig. 4. Incomplete Removal of Blind Spline in One of Four Areas

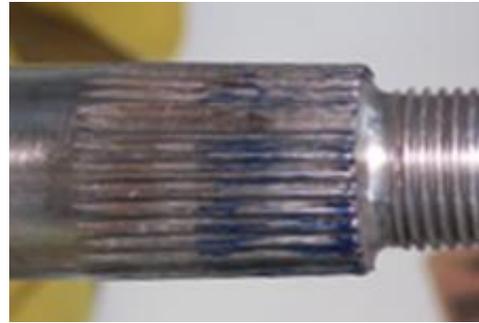
Original Pitman Arm to Original Sector Shaft Fit-up – Fig. 5 shows a near 100% contact pattern between the original Pitman arm and the original sector shaft. There are some minor high and low spots, but the pattern is consistent all around the spline. The ending gap between the Pitman arm face and the start of the sector shaft spline was one-eighth inch. This pattern and off-set gap, demonstrated by the original parts, with 130 lb-ft of torque applied to the retaining nut, was set as the standard by which to judge the NOS part assembly.

Fig. 5. Using Prussian Blue to Check Interference Pattern of Original Parts

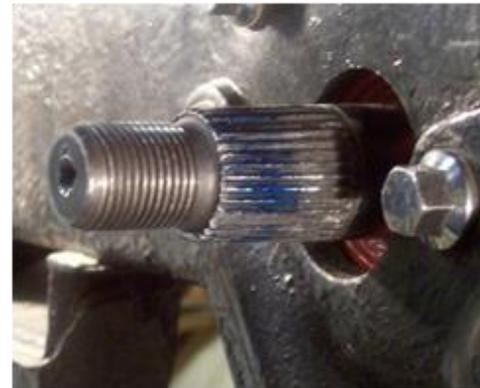
Fig. 6. Using Prussian Blue to Check Interference of NOS Parts

Fig. 6 shows sector shaft high spots revealed by using the blueing procedure explained previously. A triangular hand scraper was used to remove small amounts of material from the blued areas. Using a hand process ensured good control of the machining operation. Using a power tool, such as a small die grinder, would have been much faster but could have easily resulted in a damaged part.

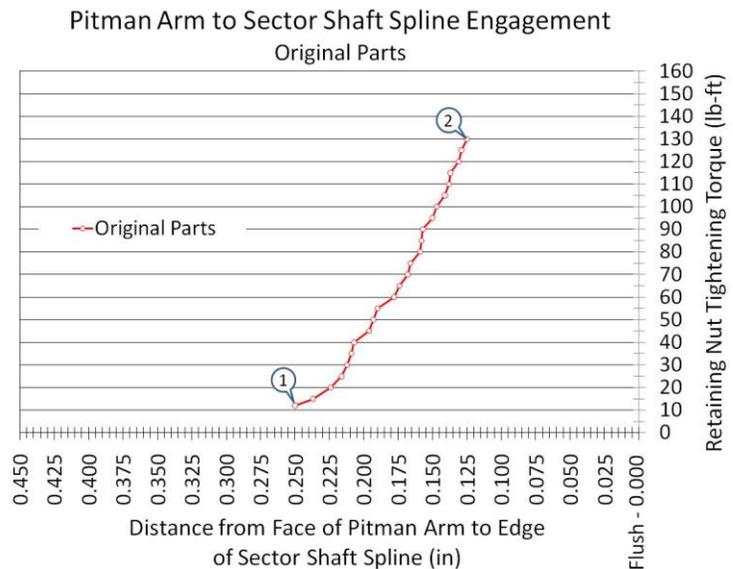
Fig. 8 shows the progression of spline engagement as a function of retaining nut tightening torque. At the start (Point 1) the Pitman was 0.250" from being flush with the edge of the sector shaft spline. At 130 lb-ft (Point 2) the remaining gap was 0.125 inch.

Fig. 8. Pitman Arm to Sector Shaft Spline Engagement using Original Parts

Although SAE torque tables<sup>1</sup> recommend a tightening torque range of 238 to 357 lb-ft for 3/4-16 Grade 5 fasteners, continuing to increase the torque did not "feel" right. Therefore a practical retaining nut tightening torque range is 125-150 lb-ft.

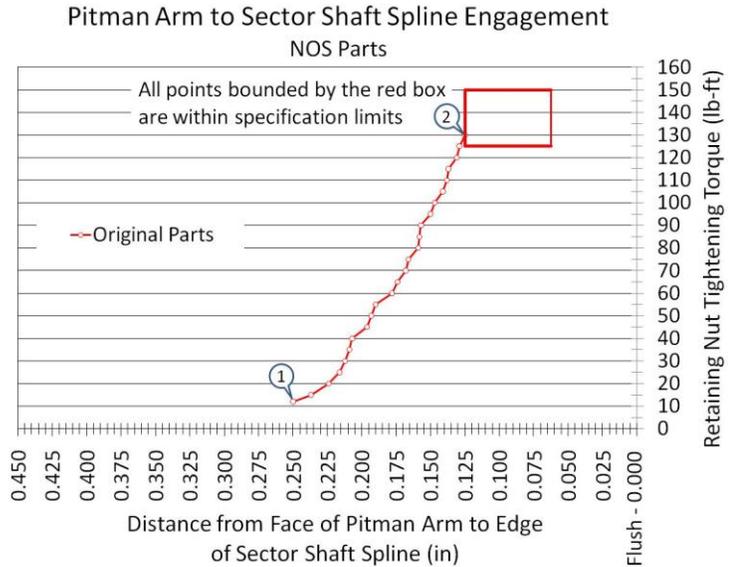
Fig. 9 shows the gap and torque limits determined by using original part assembly data from Fig. 8 and in-service reference data. The Pitman arm to sector shaft assembly specification is:

Fig. 9. Specification Conformance of Original Pitman Arm to Original Sector Shaft Spline Engagement

Gap between Pitman arm face and edge of sector shaft: 0.062”-0.125” with 125-150 lb-ft torque applied to the retaining nut. Graphite based anti-seize compound applied to sector shaft spline and threads. SAE 30 motor oil used as lubricant between nut and washer.

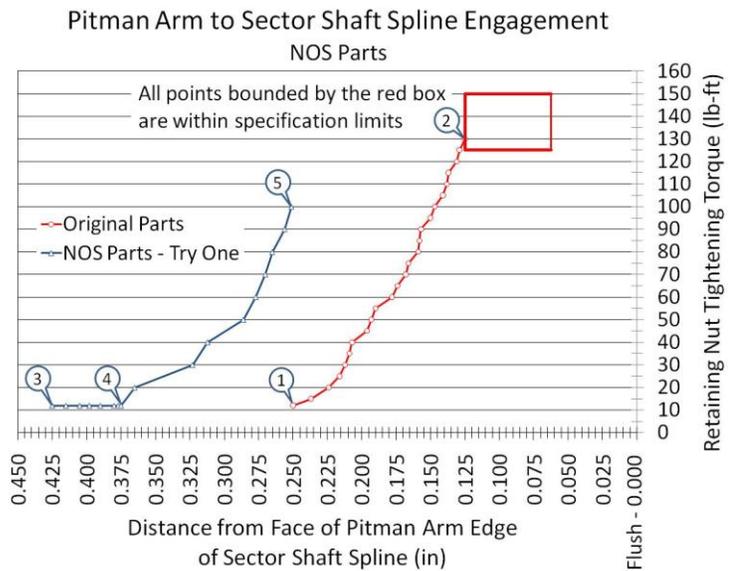
Fig. 10 shows that at 10 lb-ft of torque the NOS Pitman arm was 0.425” (Point 3) from full engagement versus 0.250” for the original parts. After repeating the blue-scraper procedure nine times, the face of the NOS Pitman was 0.375” (Point 4) from the edge of the sector shaft spline.

Although the Pitman arm was 0.125” farther out than the original parts at 10 lb-ft (Point 1), an assembly attempt was made. The linear progression from 10 lb-ft to 50 lb-ft was encouraging. However, at 100 lb-ft (Point 5) it became apparent that with almost 1/8” more engagement needed, full engagement would most

Fig. 10. Pitman Arm to Sector Shaft Spline Engagement using NOS Part –First Attempt

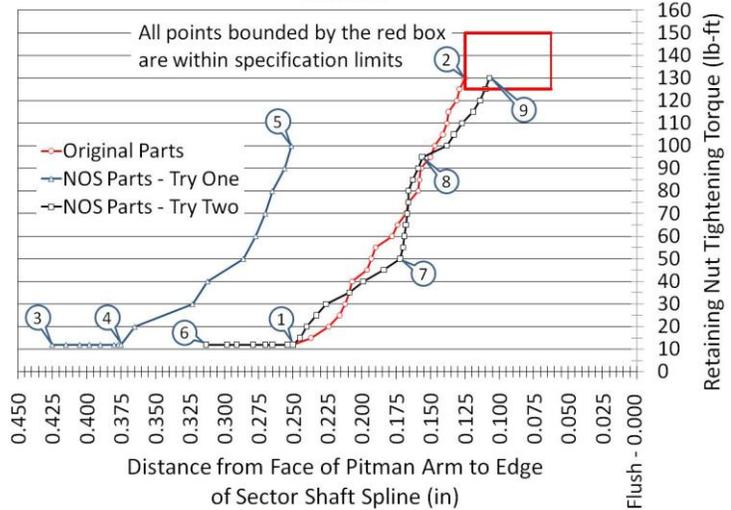
Fig. 11 shows that the next blue-scrape procedure started at Point 6 and repeated until spline engagement at 10 lb-ft was the same as for the original parts at 10 lb-ft (Point 1).

The progression of engagement verses applied torque continued to follow the pattern of the first try up to 50 lb-ft (Point 7). At that point, the torque increased with very little engagement increase (Point 8). The nut was removed and lubricant applied between it and the washer to reduce friction. The lubricant resulted in a greater rate of engagement at each applied torque setting. At 130 lb-ft of torque, the NOS parts were engaged 0.018” further on the shaft than the original parts (Point 9) and within the specified limits.

Fig. 11. Pitman Arm to Sector Shaft Spline Engagement using NOS Parts –Second Time

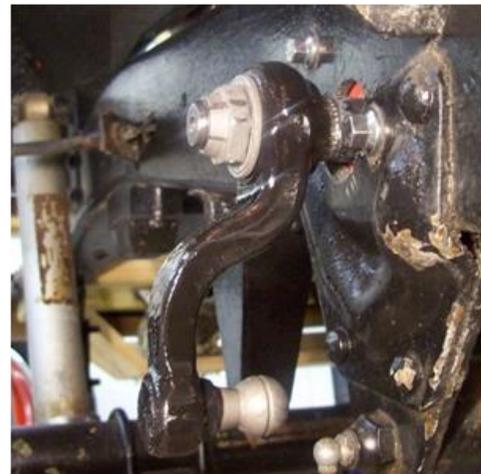
When the Pitman arm to sector shaft spline engagement and retaining nut tightening torque falls within the specification limits shown in Fig. 10, an acceptable installation is achieved. Fig. 12 shows an acceptable Pitman arm installation on the subject vehicle.

Fig. 12. Acceptable Pitman Arm Installation

Care must be taken to minimize the amount of material removed splines since their surfaces are hardened. Material removal did not exceed 0.010 inch. Surface hardness depth is estimated at 0.030 inch. *Ensure that the splines are clean and free of paint. Painted surfaces will prevent proper spline engagement.*
